## A Study on Characteristics of Underutilized and Unutilized Land in City Center of Provincial City

-The Case Study in the City Center of Ishinomaki after the Disaster-

Tomohiro, KARIYA\*, Michio, UBAURA\*\*

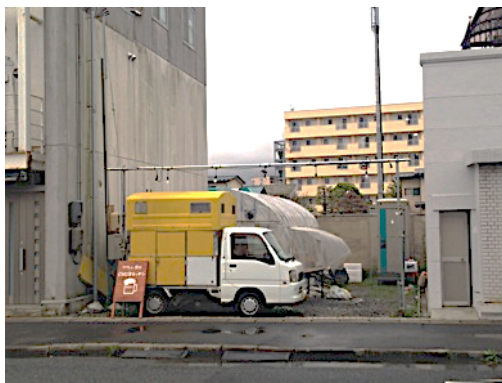
Photo.1 Land utilization in Case A

As described above, renewed buildings can be seen in areas close to public facilities and where the damage was comparatively minor. Conversely, reconstruction has not progressed in areas that suffered heavy damage or that are located far from public facilities. In addition, even when the investigation of land utilization can proceed, the land that was used for narrow shops or housing are small in terms of area, and it is difficult to create plans for their utilization. Under such circumstances, there are visible efforts to bring some life to these narrow lots by leveraging them for temporary use. In Case A (building area of the former structure: 45.7 m<sup>2</sup>),

with the consent of the landowner, a food truck has been placed on the property where it carries out the night-time sale of food and drink. In Case B (building area of the former structure: 79.5 m<sup>2</sup>), in collaboration with a local community development agency, local university students managed and operated a rest space for about a week in conjunction with a local event.
